# HOME INSPECTION REPORT

**Inspection Date:**  
8/21/2015

**Prepared By:**  
AAA Inspection Services, LLC  
312 Crawford Street, Fairfield, AL 35064

**Report Number:**  
6187

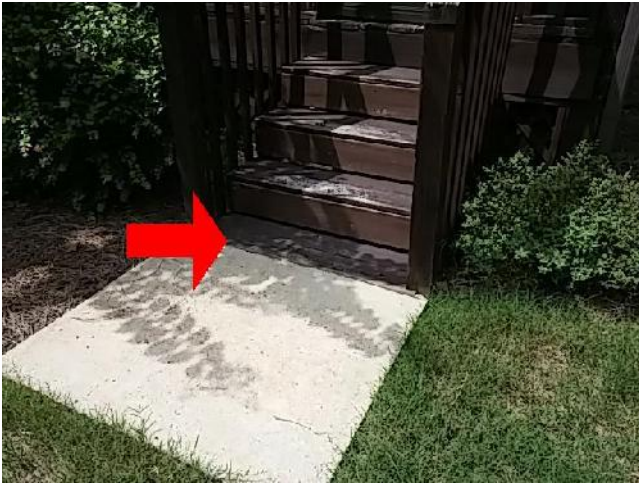
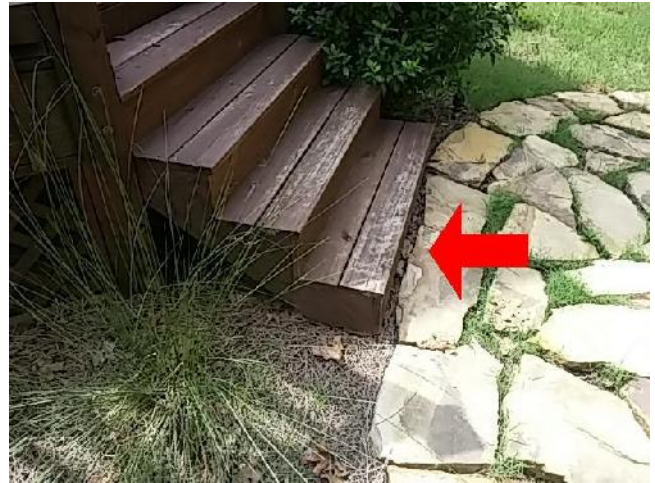
Material: Wood  
Other: Brick  
Condition: **Marginal**  
Comments: Deck steps in contact with soil should be sitting on concrete pads
